**Cottonwood Creek (HSA 4.51)** at Cottonwood Creek Park downstream (d/s) of Coast Highway (Hwy) crossing (xing). 2005 Thomas Brothers page 1147 B6. Streamflow ~ 0.75 cfs. Riparian restoration in progress. Riparian habitat consists of willow, cottonwood, cattails, California evening primrose, watercress and other vegetation.

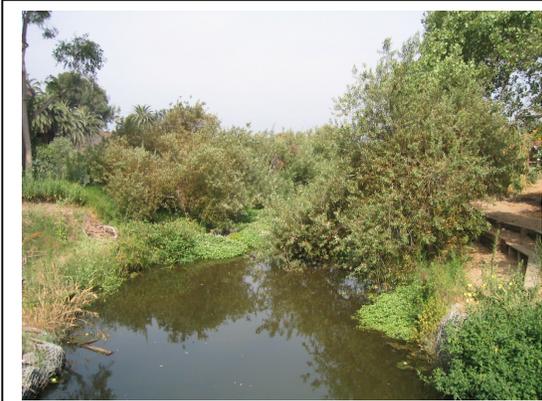
a. Cottonwood Creek, at Cottonwood Creek Park downstream (d/s) of Coast Highway crossing. Willow riparian habitat. July 12, 2005 0905hrs.

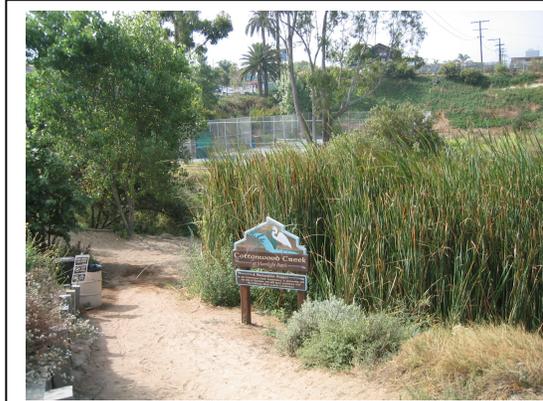
b. Cottonwood Creek, at Cottonwood Creek Park d/s of Coast Hwy xing. Willow riparian and cattails. July 12, 2005 0903hrs.

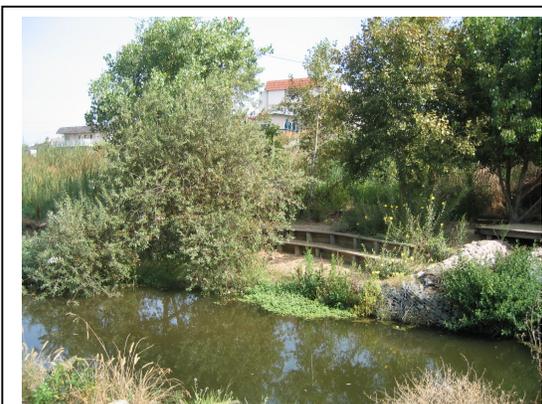
c. Cottonwood Creek, at Cottonwood Creek Park d/s of Coast Hwy crossing. Willow riparian habitat. July 12, 2005 0905hrs.

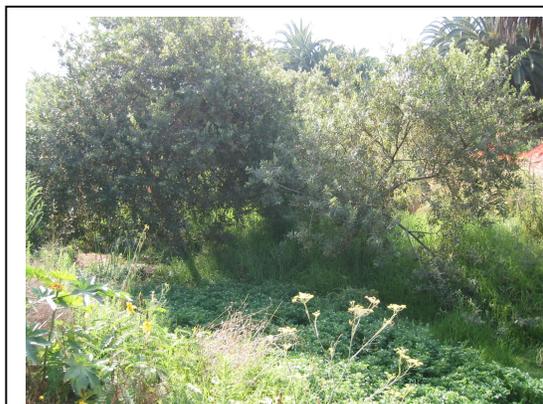
d. Cottonwood Creek, at Cottonwood Creek Park d/s of Coast Hwy crossing. Willow riparian, watercress. July 12, 2005 0911hrs.

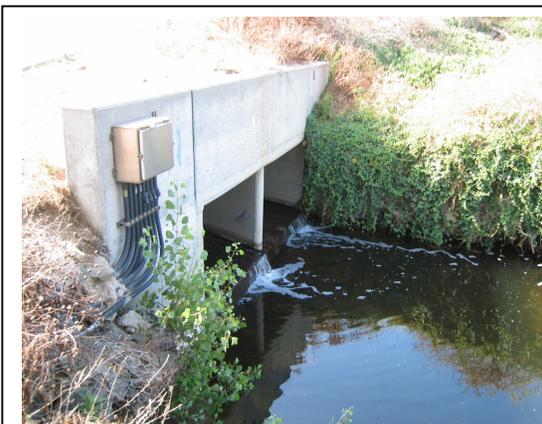
e. Cottonwood Creek, at Cottonwood Creek Park d/s of Melrose Avenue crossing. Flow ~  $\frac{3}{4}$  cfs on July 12, 2005 at 0913hrs.

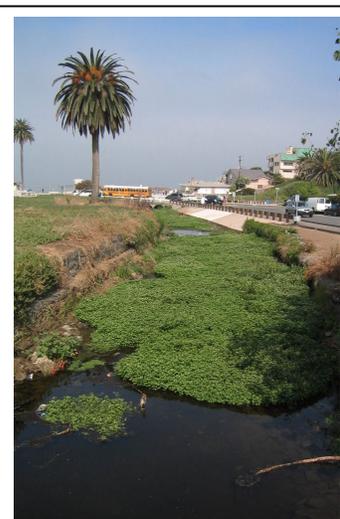
f. Cottonwood Creek, d/s of Melrose Avenue xing looking towards Moonlight Beach.

Watercress covers creek.

July 12, 2005  
0912hrs.
